# MER, CRP, and Sub-bottom Profiling to Quantify Sediment Thickness Over Rock

As part of a comprehensive geophysical and hydrological evaluation of the Cap Juluca Resort property (Anguilla, BWI), NSN utilized multiple electrical resistivity techniques combined with seismic reflection profiling to guide the conversion of two stagnant salt ponds into functional marine habitats. The purpose of mapping the salt ponds was to determine the depth to rock (for construction of horizontal flushing channels), thickness of unconsolidated sediments, quantify the amount of sediment overlying rock, and to identify subsurface anomalies within the limestone (e.g., karst features). The resistivity and sonar methods revealed excellent agreement, thereby providing increased confidence in the final results and recommendations.

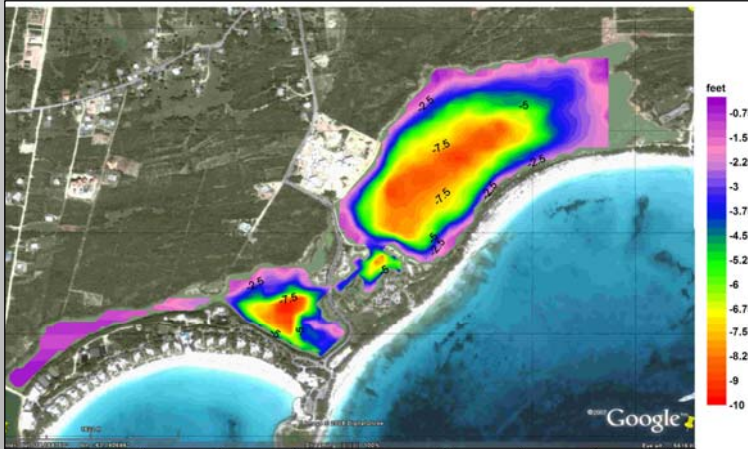
Bathymetry data collected by NSN within the two salt pond systems that back the Cap Juluca resort property.

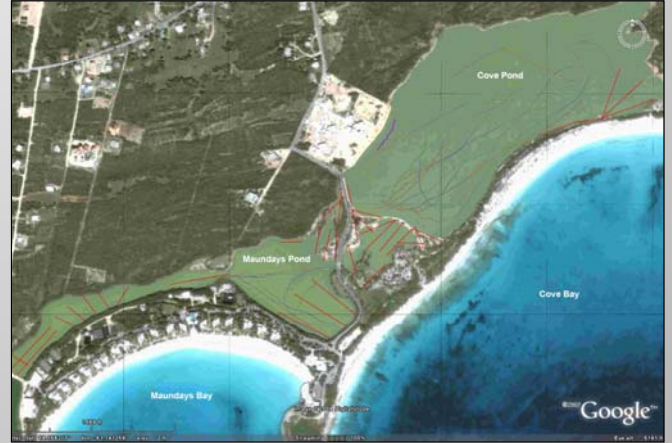
MER (red lines) and CRP (multicolored lines) transect lines.

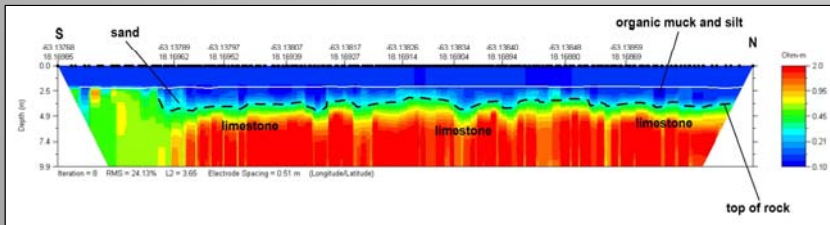
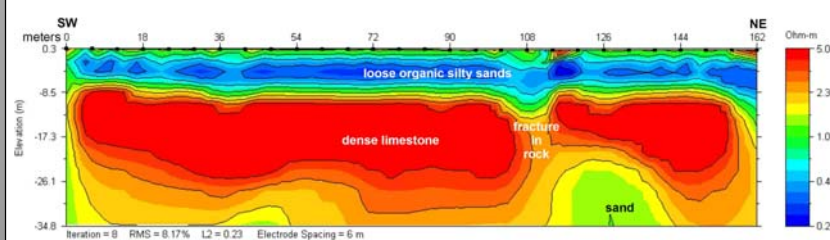
**Upper Panel:** Towed CRP profile within the salt pond.  
**Middle Panel:** Stationary MER transect within the salt pond.  
**Bottom Panel:** Seismic reflection profile within the salt pond.
