Mapping Sinkhole Collapse in Public Roadway

Our company was contracted to perform a geophysical investigation to define the boundaries of a sinkhole that had opened near a retention drainage system along a major roadway in Palm Harbor, FL. NSN performed this initial geophysical investigation using our Supersting R8 resistivity/IP unit produced by Advanced Geosciences, Inc. A series of 5 transects were performed over and parallel to the sinkhole extending from either side of the feature. This investigation ultimately led to a comprehensive Cone Penetrometer Testing program which validated anomalies discovered during the geophysical phase of this project. This emergency project was completed at the request of Pinellas County Department of Public Works and with the cooperation of the Florida Department of Transportation.

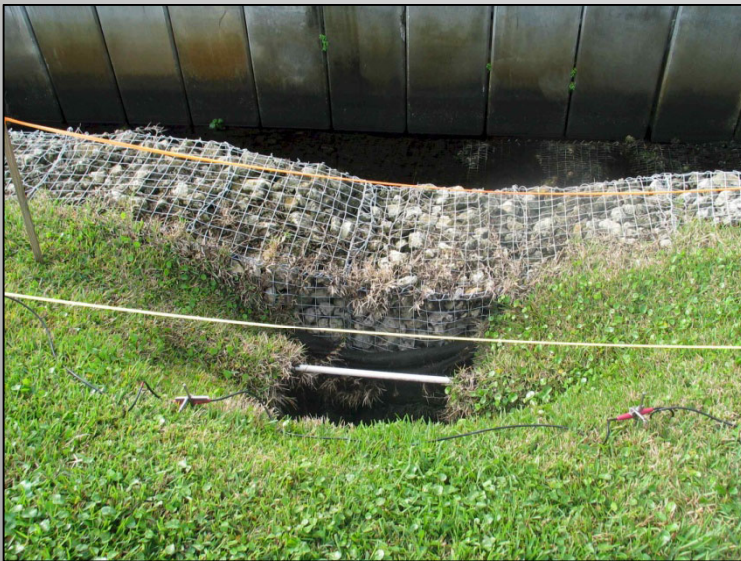
Sinkhole Collapse Feature

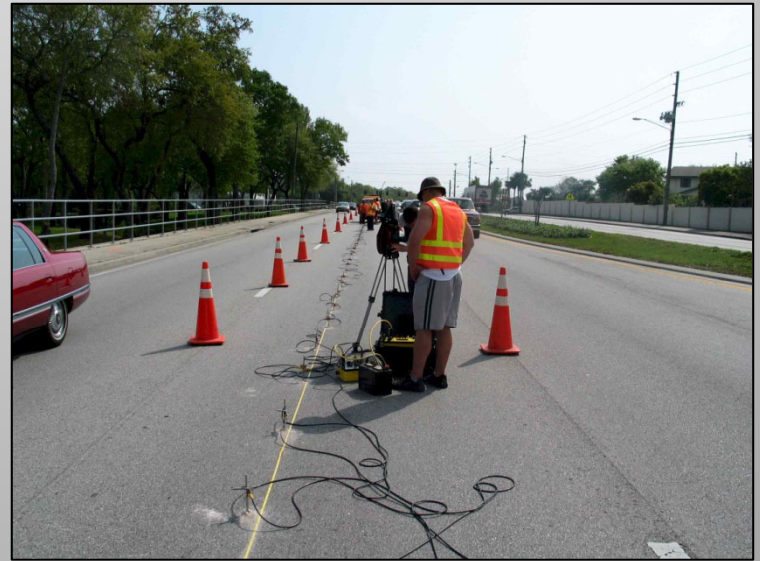
MER Transect in Roadway

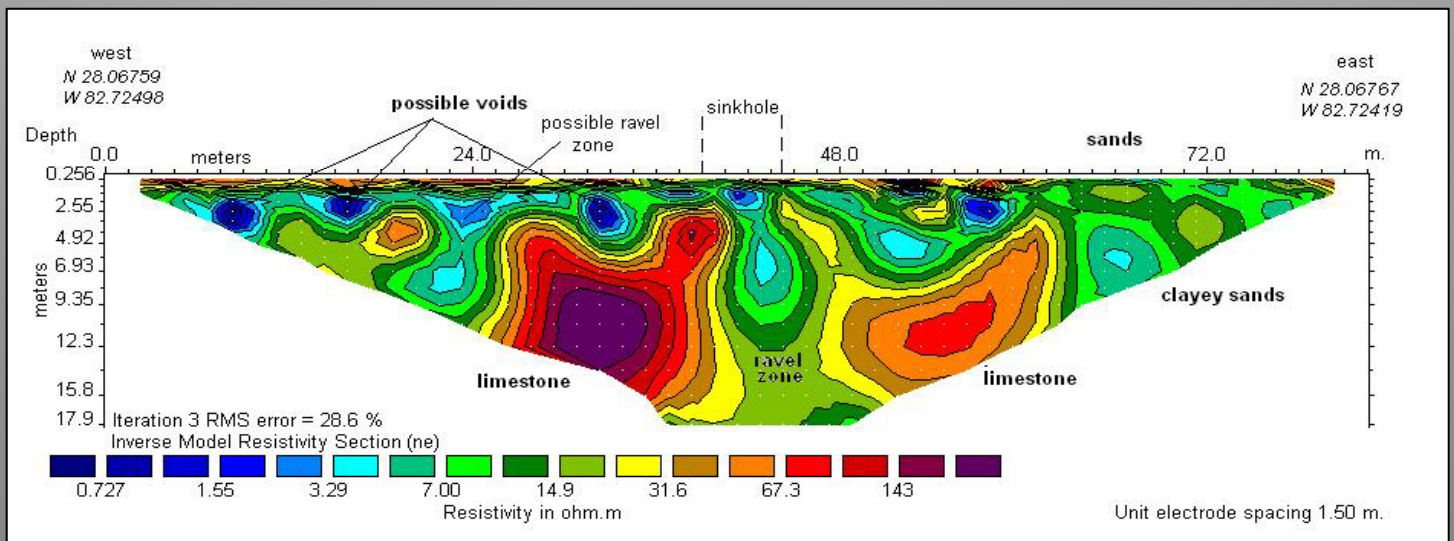
MER Transect Inverted Resistivity Profile
